**Taconic & Green  
School District**

**FACILITIES EVALUATION REPORT  
SCHOOLS OF THE TACONIC + GREEN REGIONAL SCHOOL DISTRICT  
JUNE 11, 2024**

## **SUNDERLAND ELEMENTARY SCHOOL**

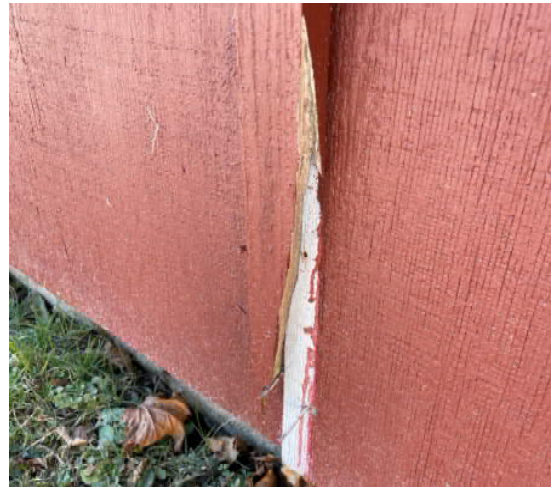
**Exterior Envelope** The exterior envelope assembly does not have a proper air barrier system and does not meet current energy code. Some areas of siding at grade level have areas of rot. Vertical siding battens are missing or damaged at many locations. Horizontal trim and exterior plywood sheathing does not have proper horizontal flashing at the top edge. Classroom exhaust louvers are no longer in use and are a source of heat loss. Exterior concrete steps and window alcove shelves have spalling of concrete and rusting of the supporting metal deck. The concrete foundation has some areas of rust jacking and spalling of concrete.

Damaged exterior siding trim

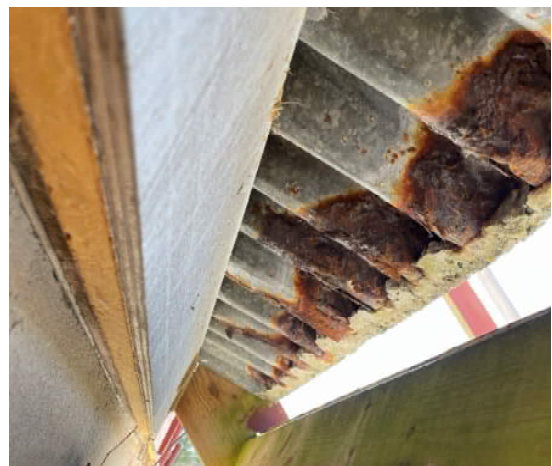
Corrosion of metal deck at entry slabs

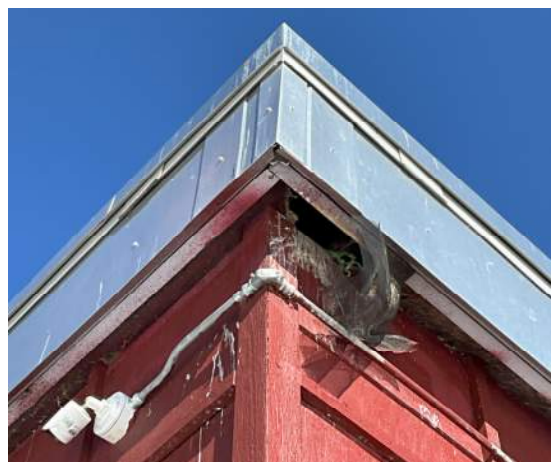
**Roofing** The roofing was not observed, but is a single-ply PVC membrane roof installed in 2007. The roof soffit vent was observed ripped and displaced at many locations around the building perimeter.

Displaced soffit vent

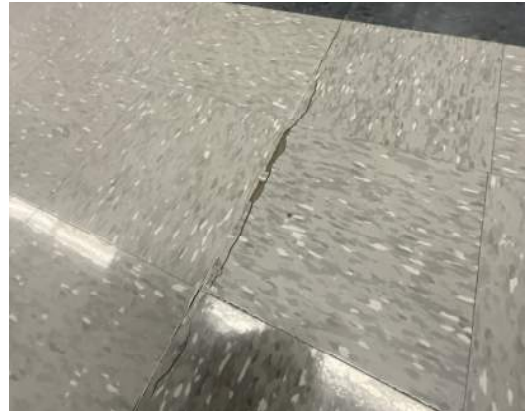
**Bathrooms** VCT flooring is cracked and separating at the joints. Many sinks do not have required P-trap protection.

Cracked VCT flooring

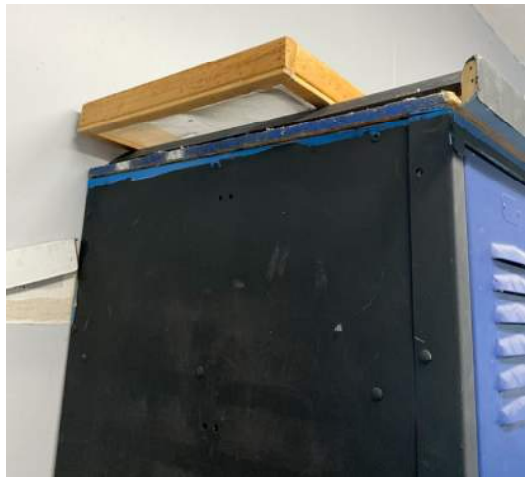
Corridor lockers in poor condition

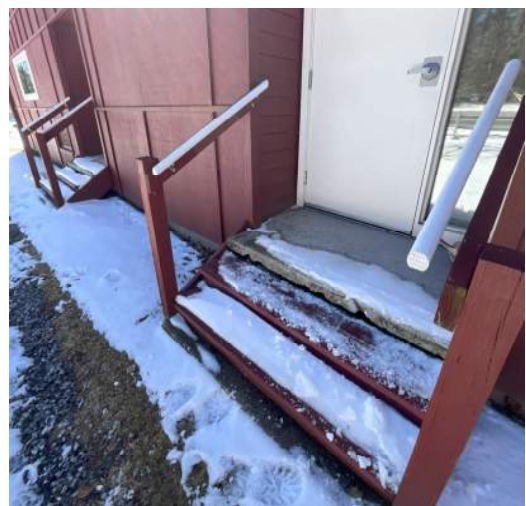
**Code / Life Safety** Exterior classroom egress doors do not meet code for egress requirements. Some exterior ramps at egress doors appear to be steeper than the code required slope.

Classroom egress doors—not accessible

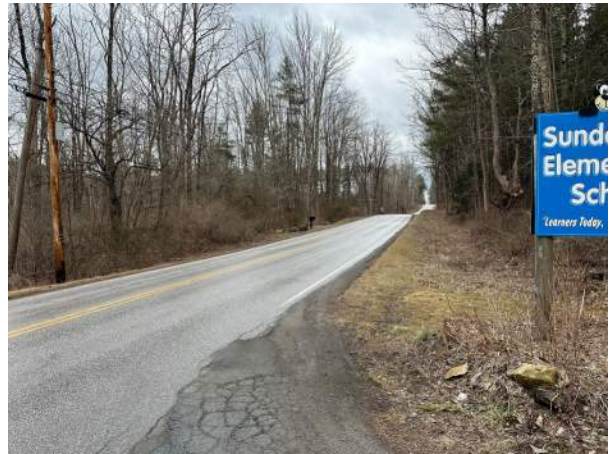
No school speed limit zone

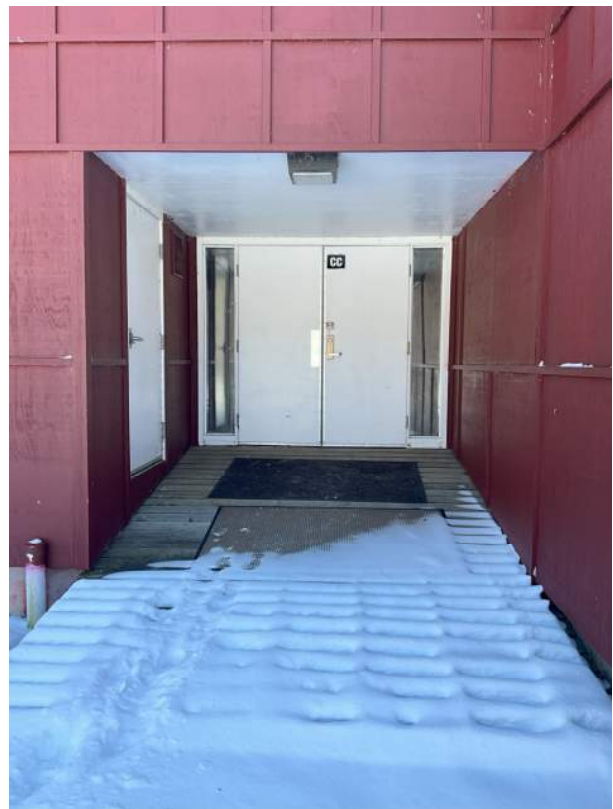
Exterior egress ramp not compliant

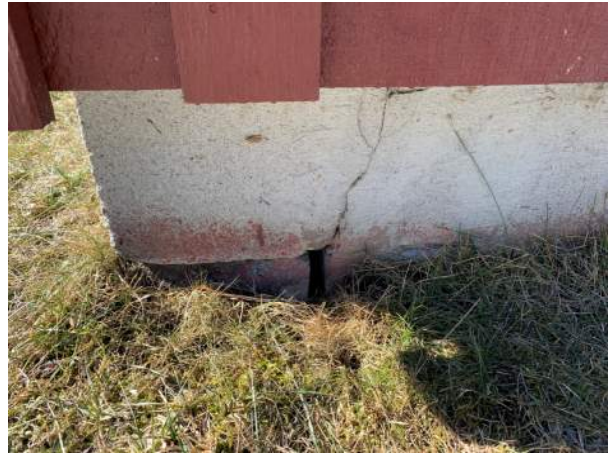
Cracks in exterior CMU foundation wall

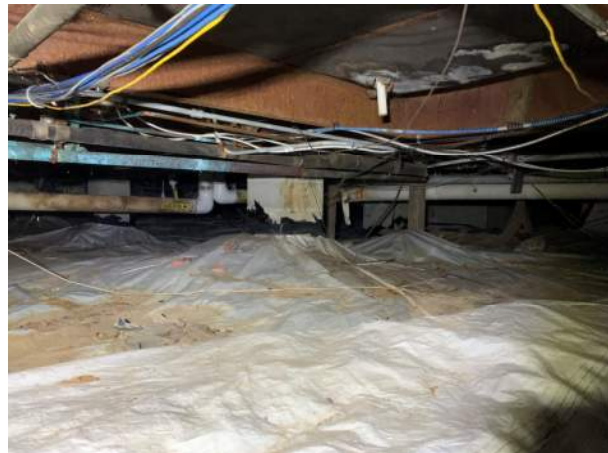
Corrosion of steel floor framing at crawl space

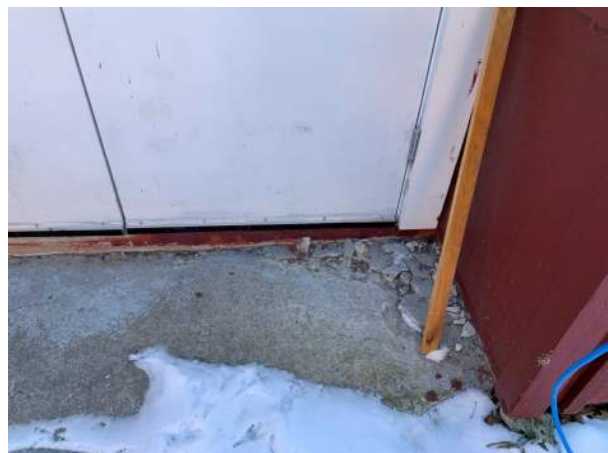
Spalling of exterior concrete slab

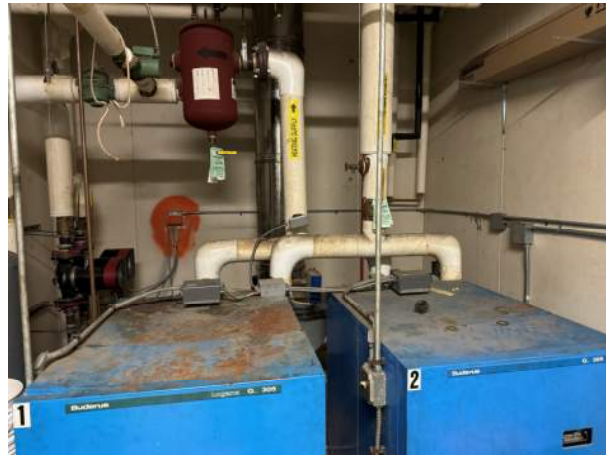
The building is provided with a two Buderus model G-305-11 section oil-fired boilers, each with a gross rating of 393 MBH. Both boilers were installed as part of the heating system retrofit in 1986. Both boilers should be replaced.

Oil boiler—near end of useful life

The oil-fired boilers should be replaced.

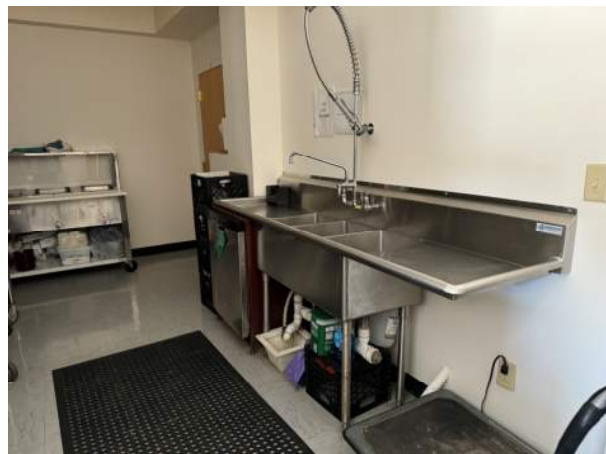
Kitchen—no dishwasher or grease trap observed

The kitchen does not have a dishwasher. We **recommend** installing a commercial grade dishwasher in the kitchen. A grease trap should be installed on the waste line.

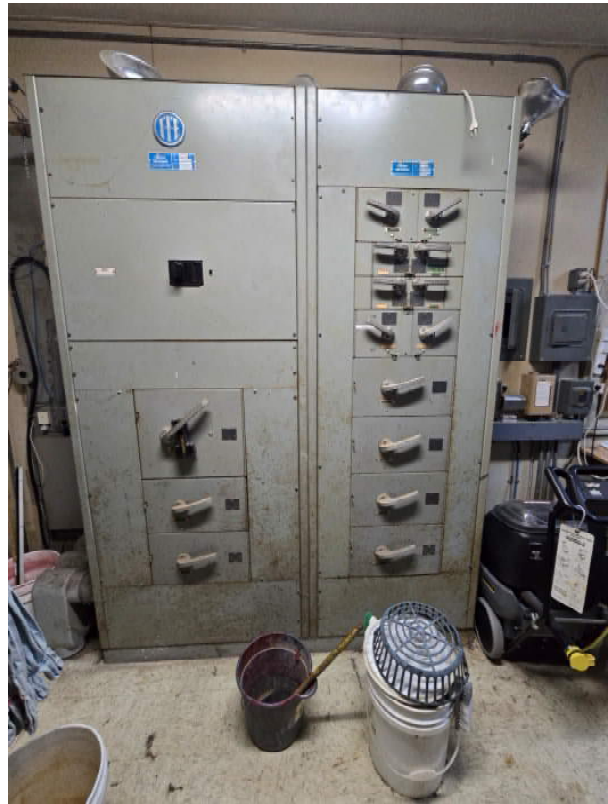
Distribution equipment is roughly 50 years old. The equipment is generally in fair condition, but replacement parts will become scarce.

Original electrical gear—nearing end of useful life
