Archeological Resource & Historic Preservation Assessment  
Sunderland Bicycle-Pedestrian Scoping Study  
Hartgen Archeological Associates, Inc.  
July 2015

### Sunderland Bicycle-Pedestrian Scoping Study

Town of Sunderland  
Bennington County, Vermont

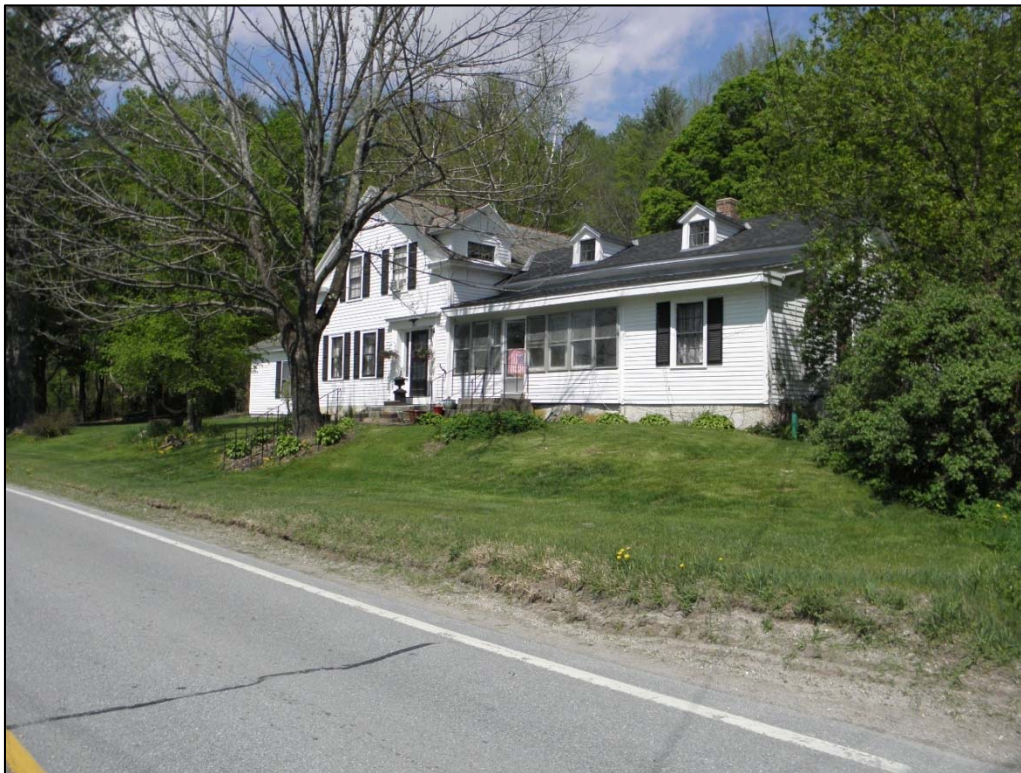
Photo 3. Structure 1, 6407 Route 7A, facing northwest. An upright-and-wing mid-19<sup>th</sup> century wood-frame house with 20<sup>th</sup> century additions.

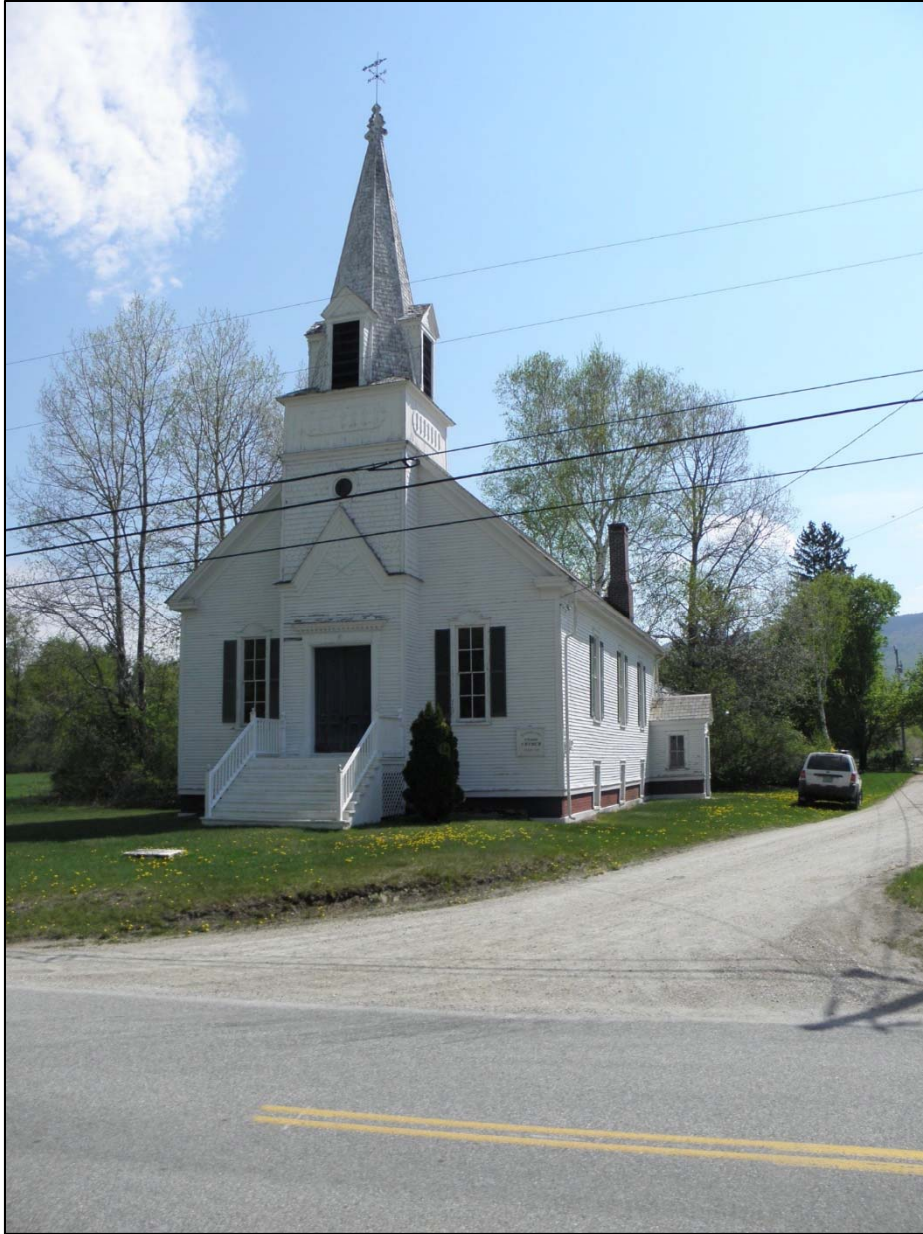
Photo 7. Structure 6, Hill Farm Road, constructed c. 1880, facing northeast. A National Register eligible vernacular interpretation of gothic revival architecture.

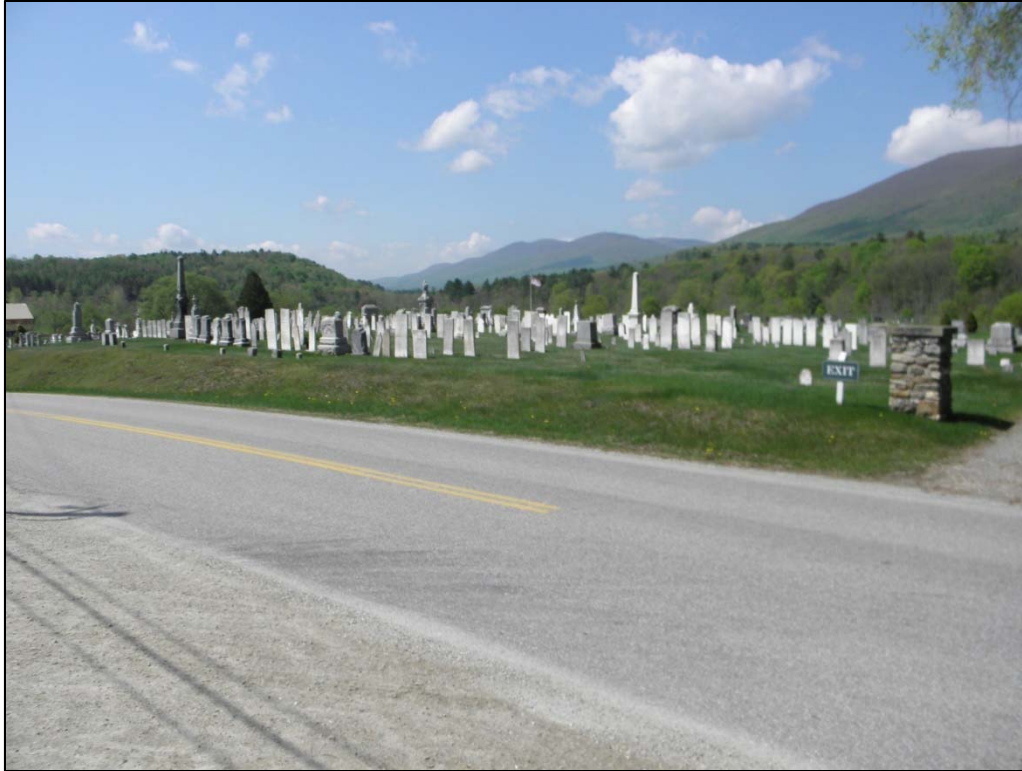
Photo 8. Structure 7, Ira Allen Cemetery on Hill Farm Road, established in 1794, facing southwest. Burials date from the late 18<sup>th</sup> century to the present.

Fieldstone retaining walls are associated with structures 31, 38, 39 and 53 (Photos 21, 25, 26, and 36). Stone posts are located in front of the cemetery (Structure 7, Photo 8) and a private residence (Structure 31, Photo 21). Impacts to these features should be avoided.

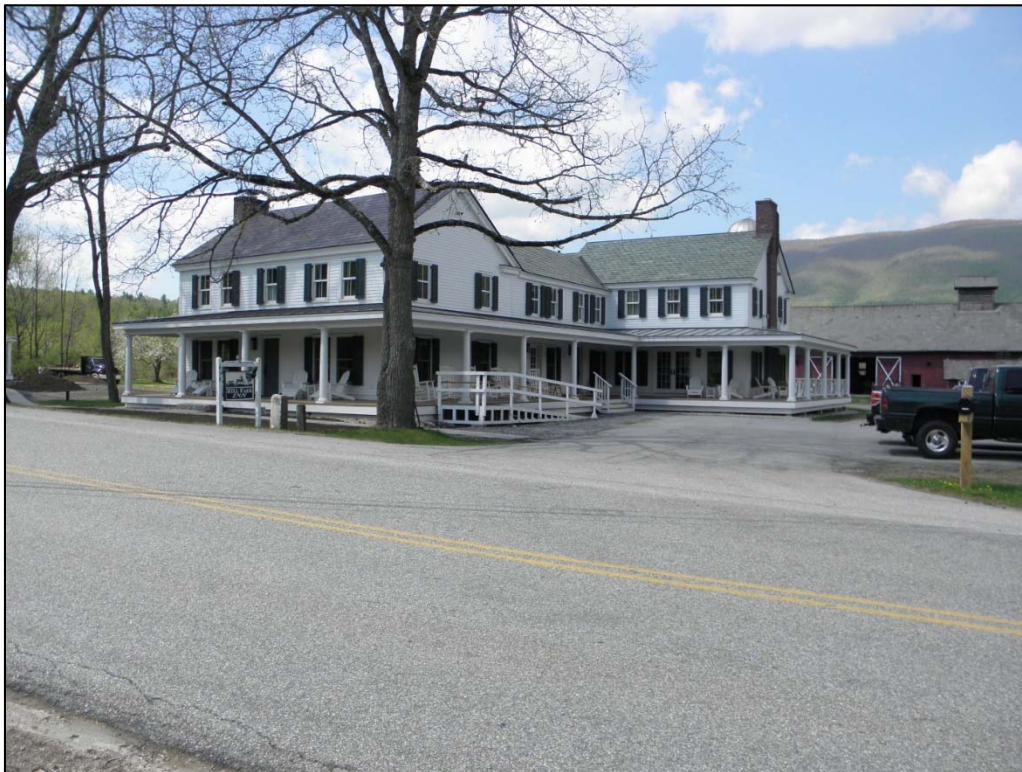
Photo 9. Structure 9, 458 Hill Farm Road, constructed pre-1820, facing southwest. A National Register eligible early 19<sup>th</sup> century two story center-passage vernacular wood-frame dwelling, with later additions.

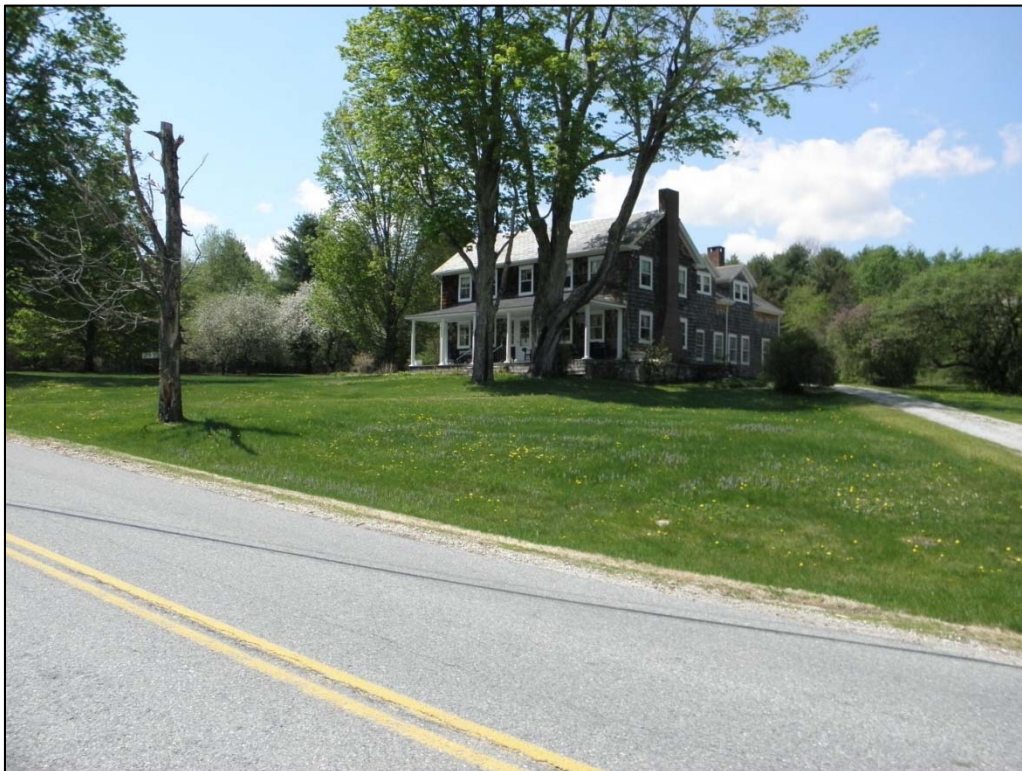
Photo 17. Structure 26, 2539 Sunderland Hill Road, facing southwest. A two-story center-passage wood-frame vernacular house, constructed in the first half of the 19<sup>th</sup> century, with later additions.

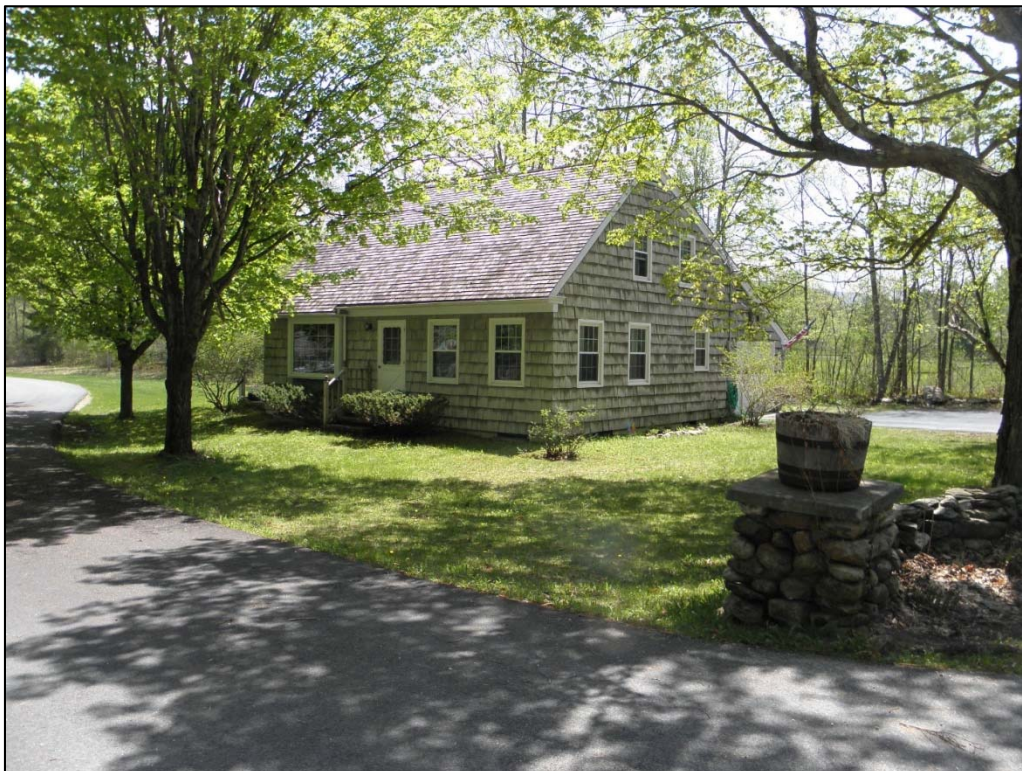
Photo 21. Structure 31, 2296 Sunderland Hill Road, facing southeast. Caretaker's house associated with Structure 30, also constructed c.1950.

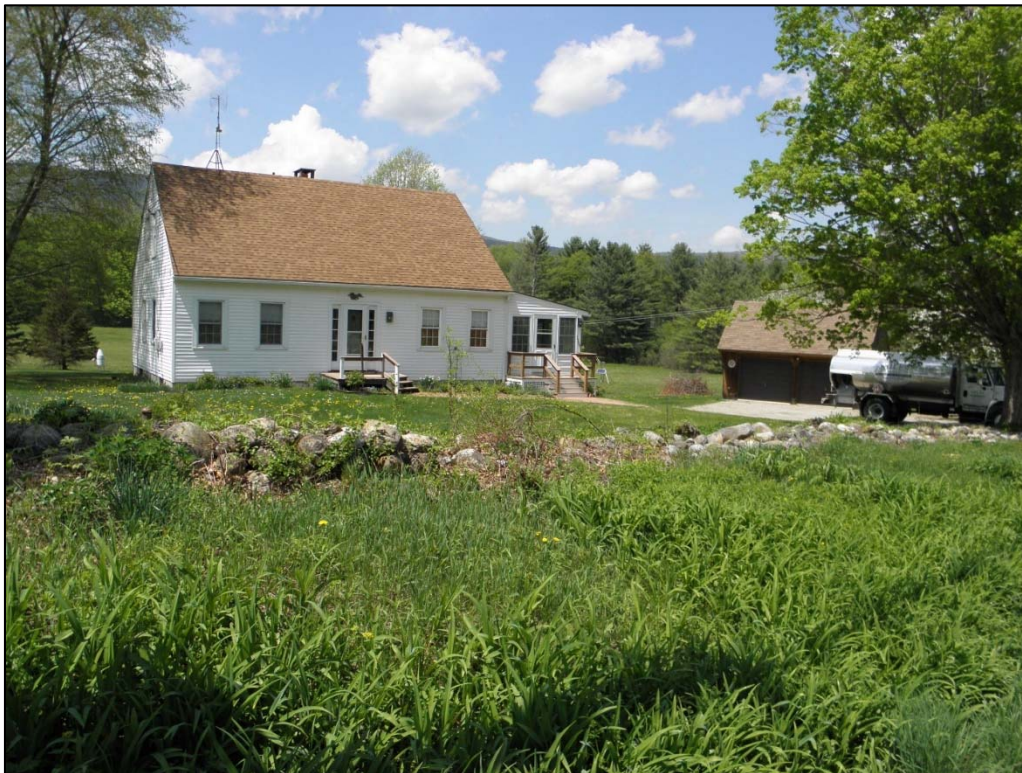
Photo 25. Structure 38, 1789 Sunderland Hill Road, facing northwest. A 19<sup>th</sup> century wood-frame classic cottage.

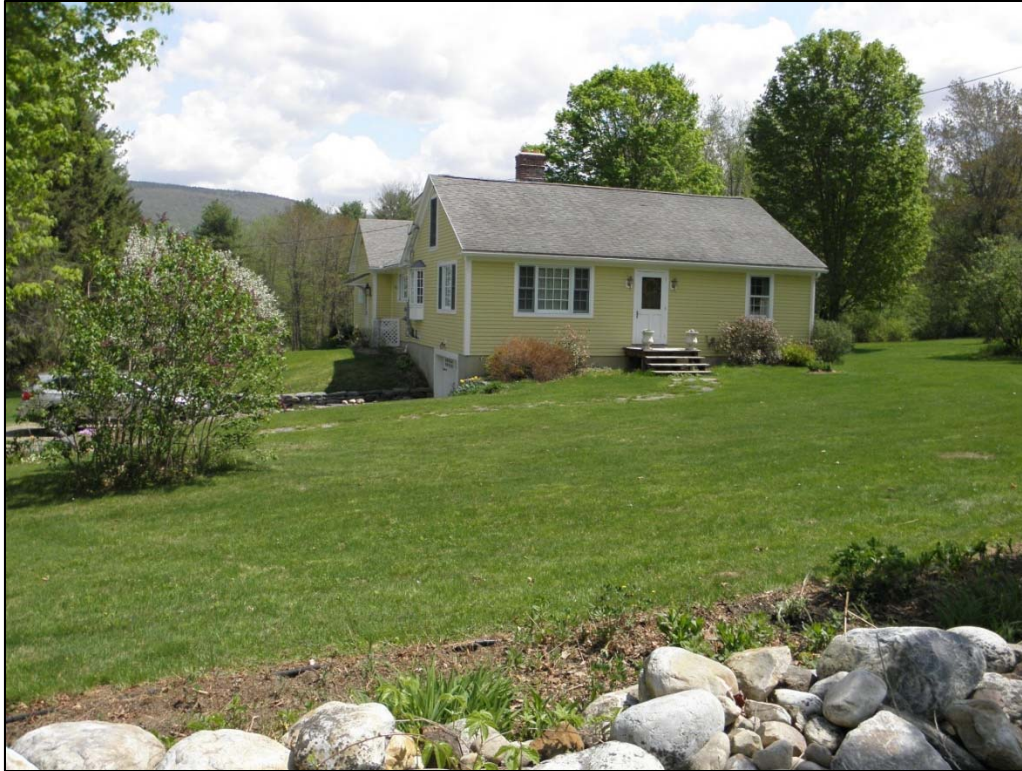
Photo 26. Structure 39, 1784 Sunderland Hill Road, facing east. A c. 1955 small ranch style wood-frame house with later 20<sup>th</sup> century addition.

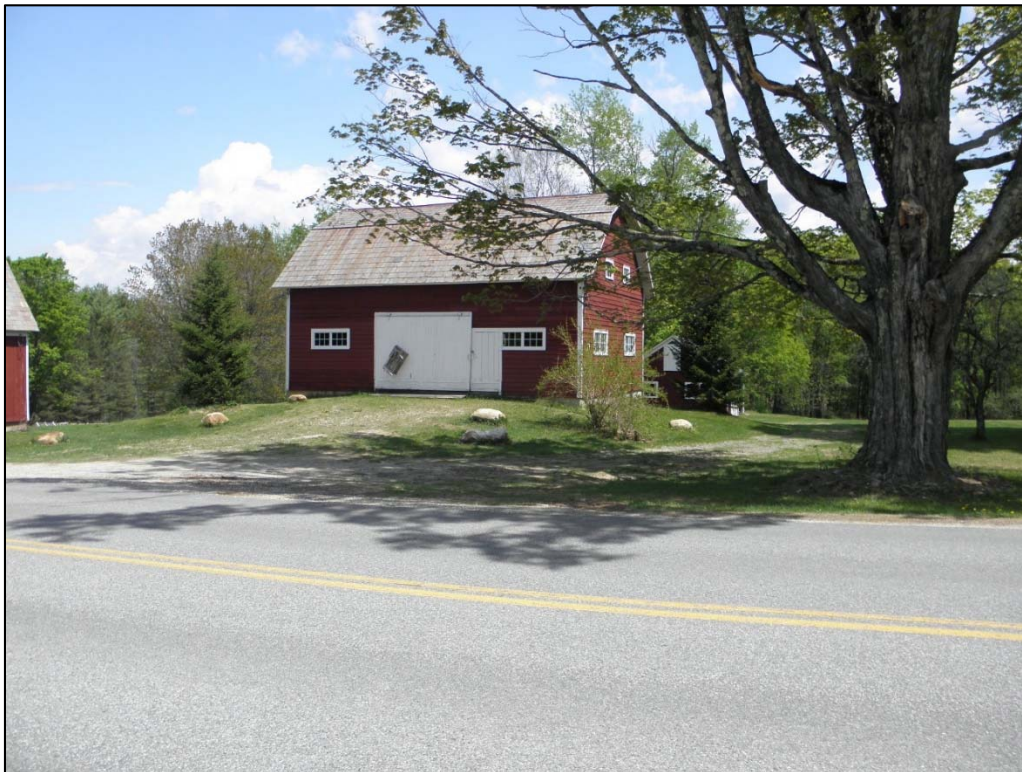
Photo 27. Structure 40, 1704 Sunderland Hill Road, facing northeast. An English threshing barn, one of two 19<sup>th</sup> century barns on one property; probably associated with Structure 41 across the road.

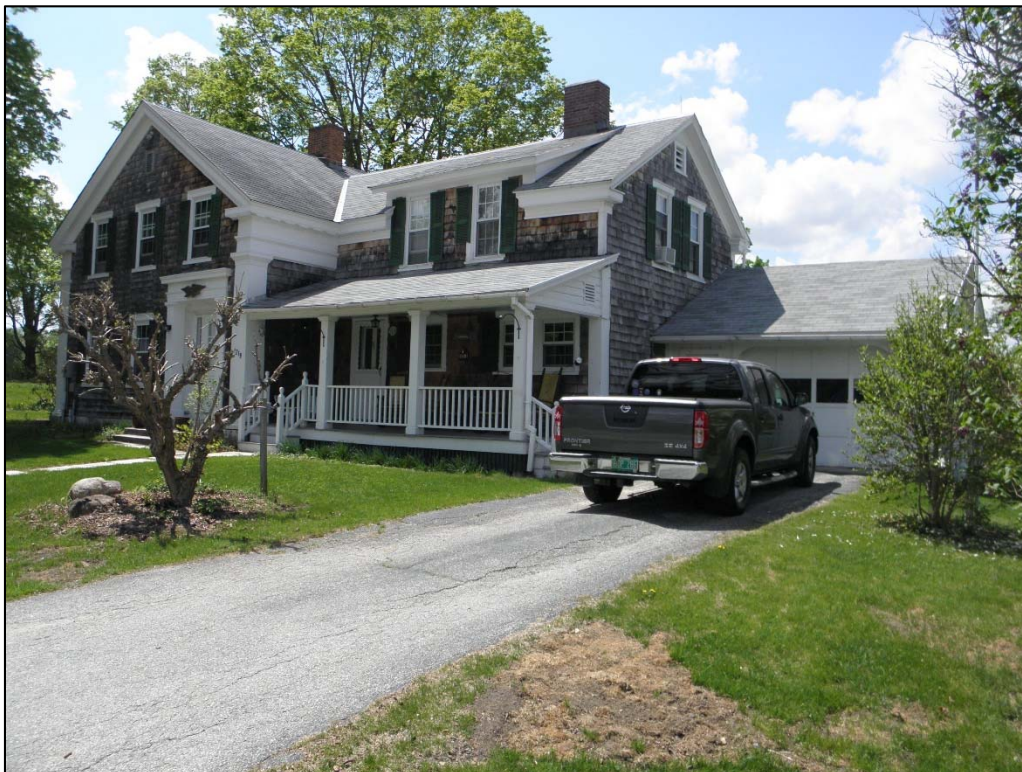
Photo 29. Structure 41, 1719 Sunderland Hill Road, facing southwest. A c. 1850 vernacular upright-and-wing with Greek revival detailing and early 20<sup>th</sup> century porch and dormers.

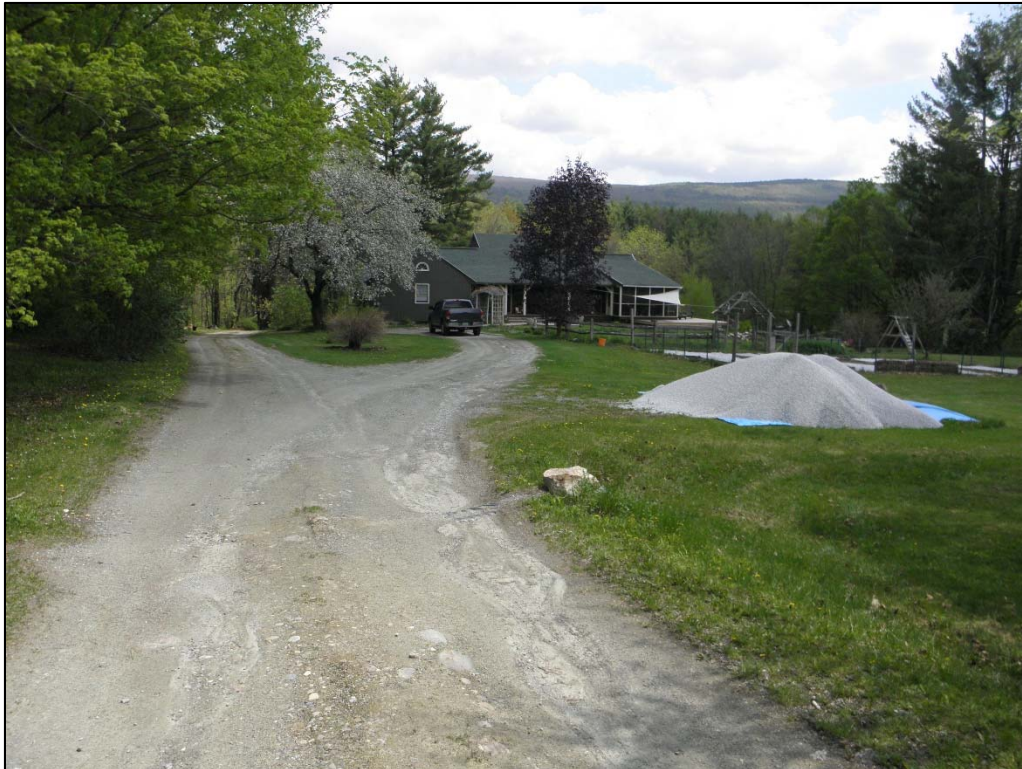
Photo 33. Structure 48, 1532 Sunderland Hill Road, facing east. A c. 1950 colonial revival wood-frame house.

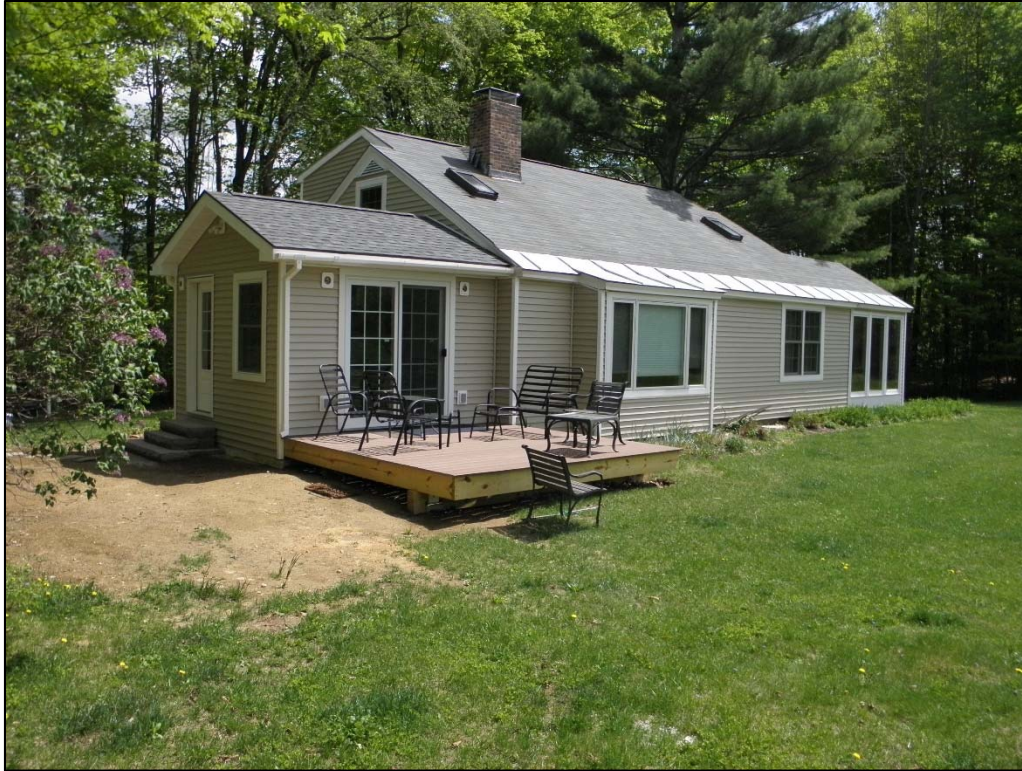
Photo 34. Structure 49, 1533 Sunderland Hill Road, constructed 1950, facing southeast. A one-story wood-frame bungalow constructed in the second quarter of the 20<sup>th</sup> century; extensively renovated in the early 21<sup>st</sup> century.

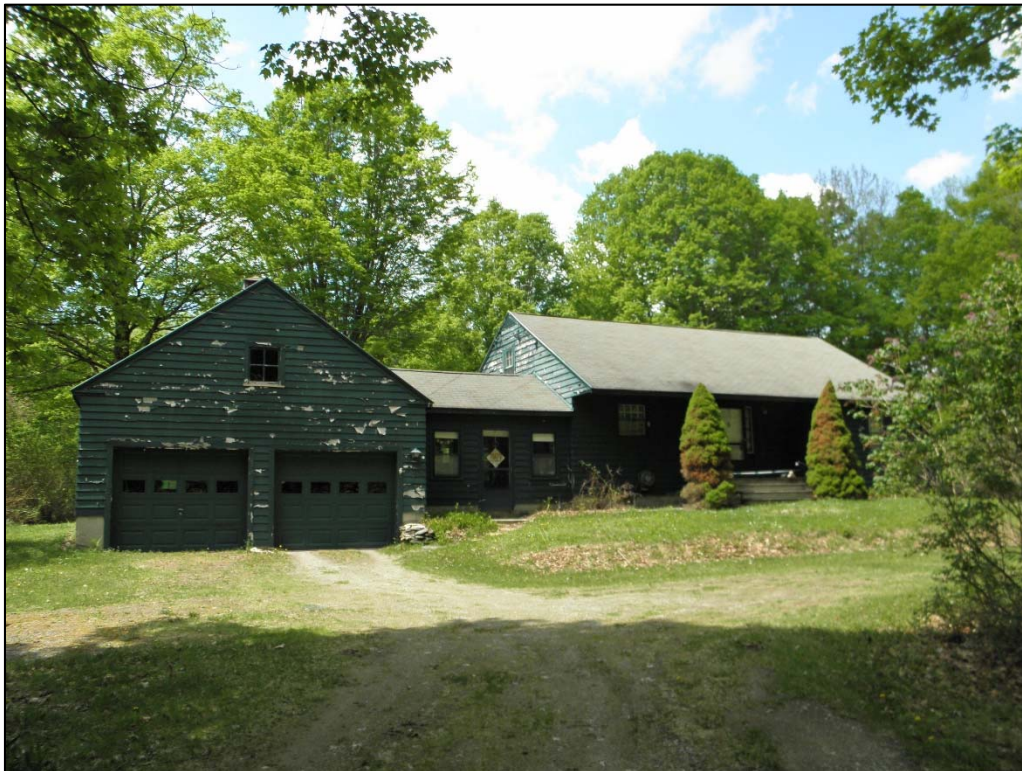
Photo 35. Structure 52, 1469 Sunderland Hill Road, facing west. A one-story c. 1955 ranch style wood-frame dwelling with attached two-bay garage and enclosed breezeway.

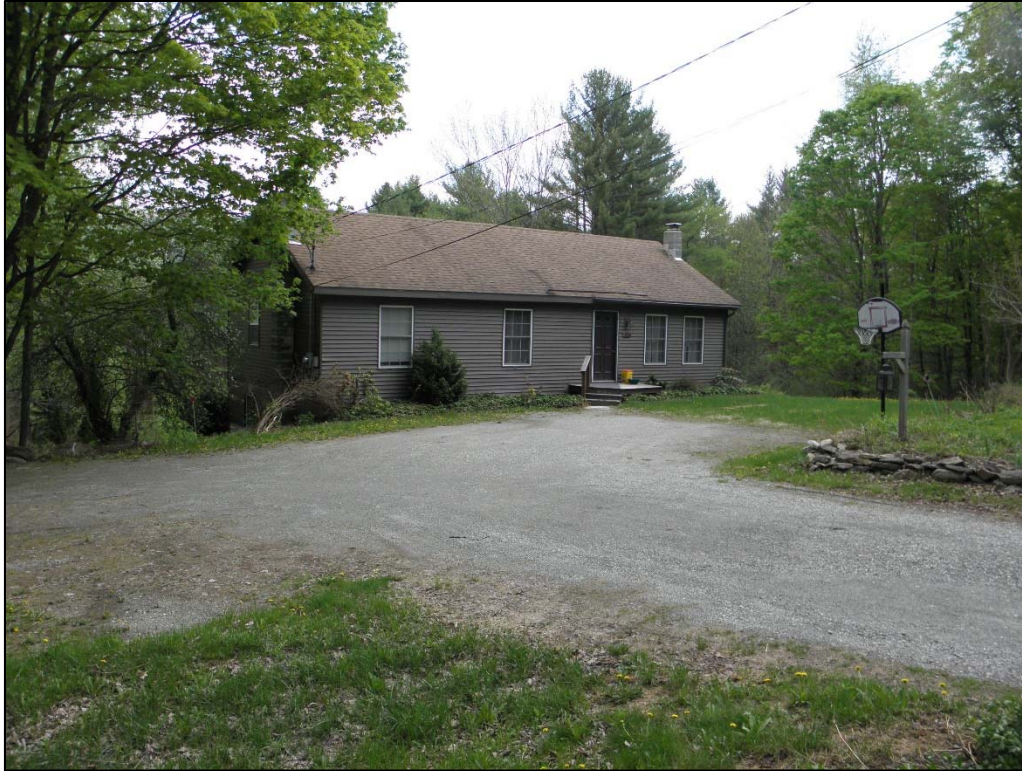
Photo 36. Structure 53, 1416 Sunderland Hill Road, facing southeast. A one-story wood-frame ranch style home, built c. 1960.

Photo 36. Structure 53, 1416 Sunderland Hill Road, facing southeast. A one-story wood-frame ranch style home, built c. 1960. ....	31
Photo 37. Structure 55, 1343 Sunderland Hill Road, facing southwest. A one-story wood-frame ranch style home, built c. 1955. ....	31
Photo 38. Structure 60, 1191 Sunderland Hill Road, facing northwest. A one-and-a-half story wood-frame side gable vernacular house built in the mid-19 <sup>th</sup> century, with early 20 <sup>th</sup> century enclosed porch. ....	32
Photo 39. Mid-19 <sup>th</sup> century English threshing barn associated with Structure 60, facing southwest. ....	32
Photo 40. Structure 63, 1078 Sunderland Hill Road, facing east. A mid-19 <sup>th</sup> century gable-entry vernacular house of one-and-a half stories and L-shaped plan. ....	33
Photo 41. Structure 64, 1063 Sunderland Hill Road, facing west. A bungalow-style wood-frame house built in the second quarter of the 20 <sup>th</sup> century with late 20 <sup>th</sup> century additions and alterations. ....	33

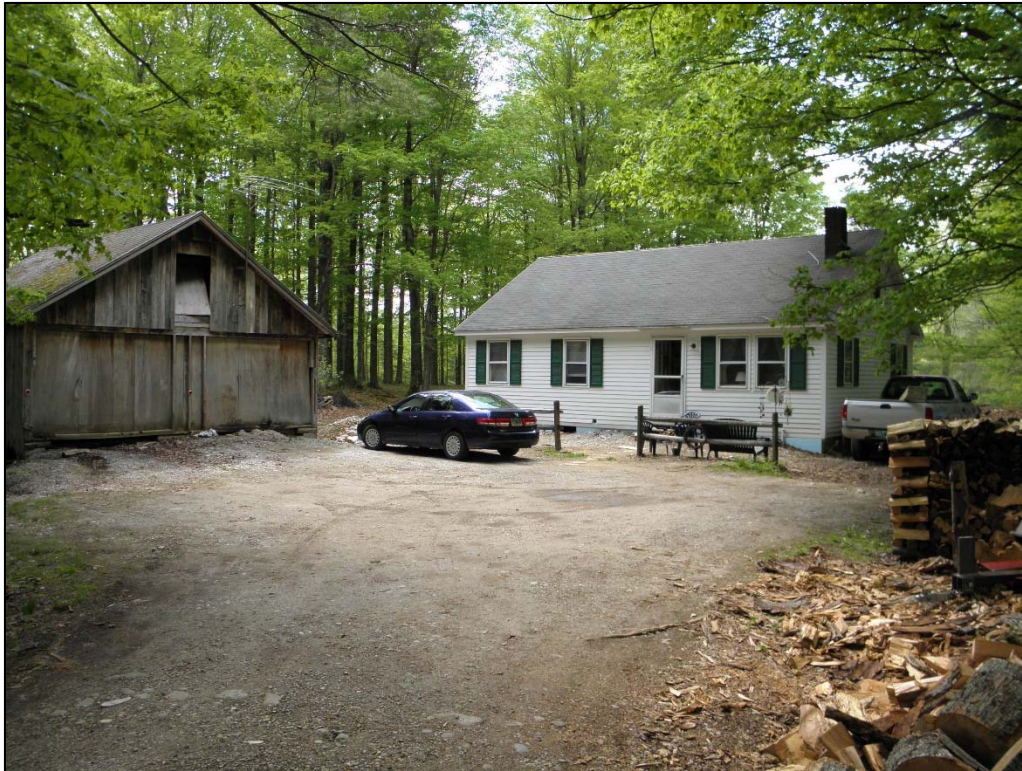
Photo 37. Structure 55, 1343 Sunderland Hill Road, facing southwest. A one-story wood-frame ranch style home, built c. 1955.

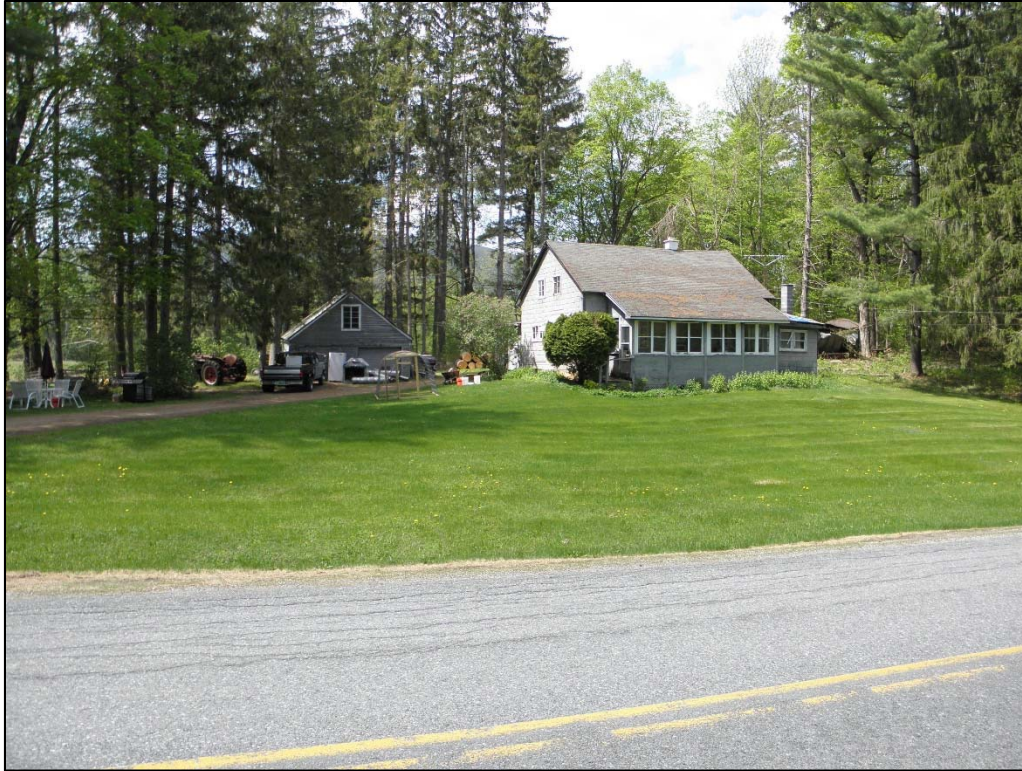
Photo 38. Structure 60, 1191 Sunderland Hill Road, facing northwest. A one-and-a-half story wood-frame side gable vernacular house built in the mid-19<sup>th</sup> century, with early 20<sup>th</sup> century enclosed porch.
